IDENTIFYING OPTIMUM PARAMETERS OF HOT EXTRUSIONS

Contract NAS 7-276

Progress Report No. 10
16 July 1966 to 18 October 1966

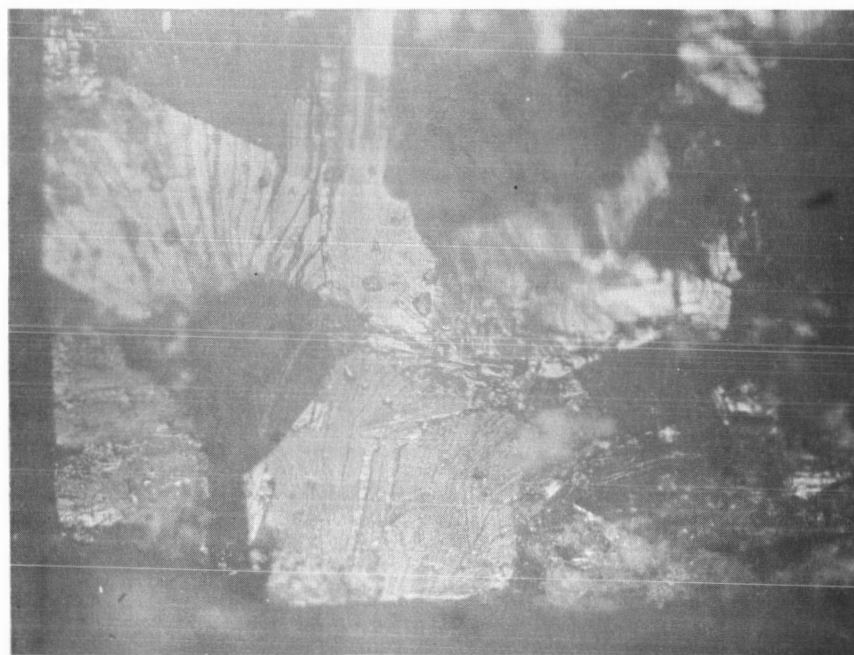
FIGURE 3 SAMPLE LONGITUDINAL FRACTURES (A) Specimen M-3-7 I_{1-1} Clearer than average fracture origin - inside specimen, (B) Specimen M-f-3 I_{1-1} clearer than average fracture origin - at surface or in 1st grain

The longitudinal fractures were almost exclusively cleavage as with transverse fractures. Most origins of longitudinal fractures could not be determined nearly as well as for transverse fracturing. This appeared to be due to a more irregular fracture topography. However, the approximate region of origin could be determined for some specimens (Figure 3). Several of these origins from sanded specimens appeared to be internal (see Figure 3A) and there were some signs of slip bands in the regions of probable fracture origin. (Figures 3B, 4A). Occurrence of a higher surface density of dislocations and slip bands was also seen in the sanded specimens (Figure 4B).

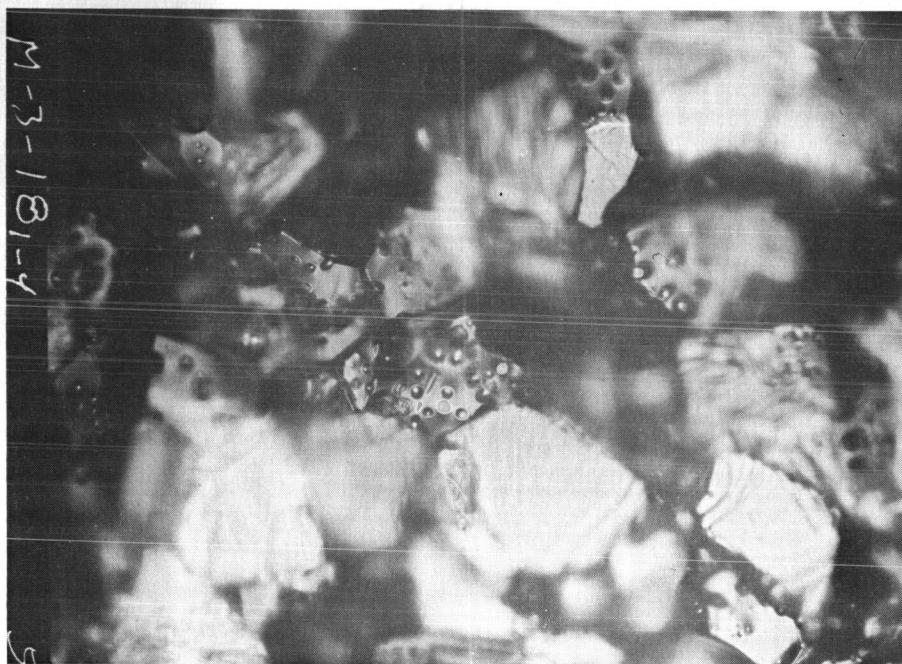
FIGURE 7 - 2400°F (1315°C) FRACTURE SURFACES OF EXTRUDED HOT
PRESSED MgO (A) M-3-52-2C, (B) M-3-18₁-4

Note: Objects on grain boundary surfaces

As noted earlier, considerable intergranular fracture occurred at elevated temperatures. The exposed grain boundaries surfaces generally had round or elongated and curved objects on them as shown in Figure 7. Similar
